LINNTON PLYWOOD ASSOCIATION – TECHNICAL EVALUATION

Upland Site: Linnton Plywood Association
10504 NW Saint Helens Road (Fig. 1)
26.5 Acres
RM 4.4 to 4.8

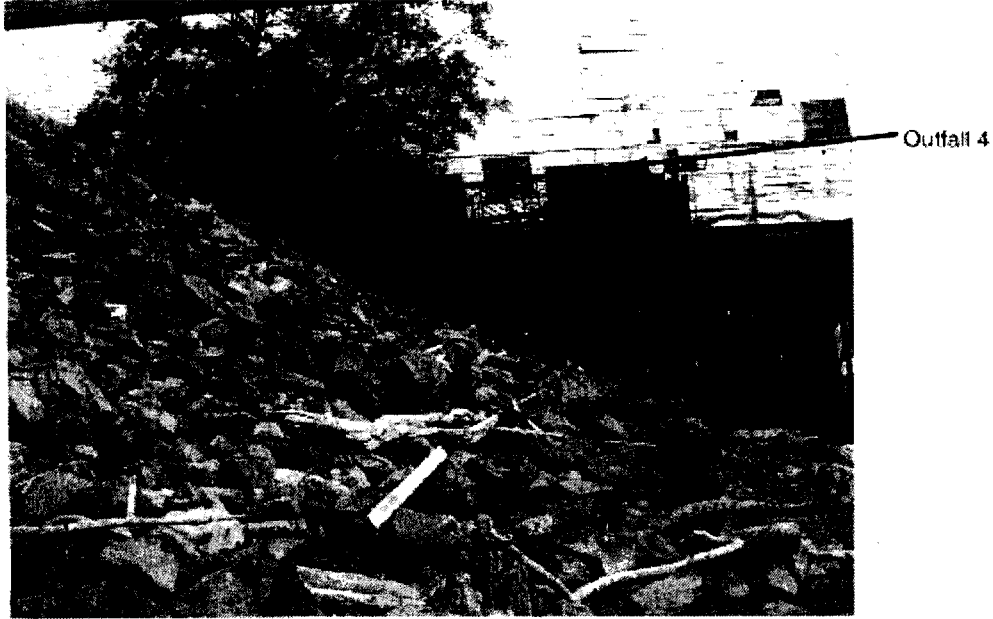
Outfall 4: Outfall 4 is located 30 feet downstream of outfall 3. This outfall drains storm water from the roofs of the plywood mill. The outfall discharges approximately 10 feet below the paved area grade onto a riprap slope above the 17 feet MSL facility boundary. This outfall was not sampled.

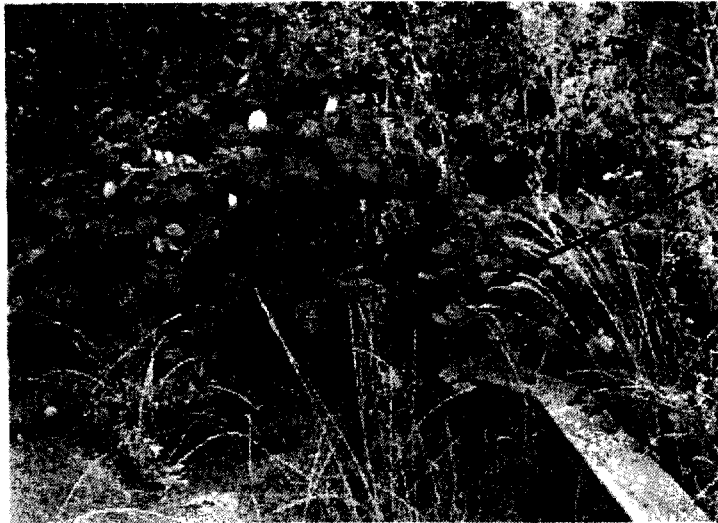
Outfall 2: The drainage basin for this outfall is the paved area on the southeast side of the plywood mill. The outfall discharges approximately 2 feet below the paved area grade onto a riprap slope above the 17 feet MSL facility boundary. Land area where sander dust ash has been placed may also drain to this outfall. Sampling shows that the following chemicals exceed screening levels for this outfall: Phenol and pentachlorophenol detection limits were too high (40-60 times SLVs) to determine whether these parameters were of concern. Sampling shows that none of the chemicals analyzed exceed screening levels for this outfall. Benzo(a)pyrene, phenol and pentachlorophenol detection limits were too high (40-60 times SLVs) to determine whether these parameters were of concern.

Catch basin
discharge on outer
side of curb.
